Case Study 13: Brenda

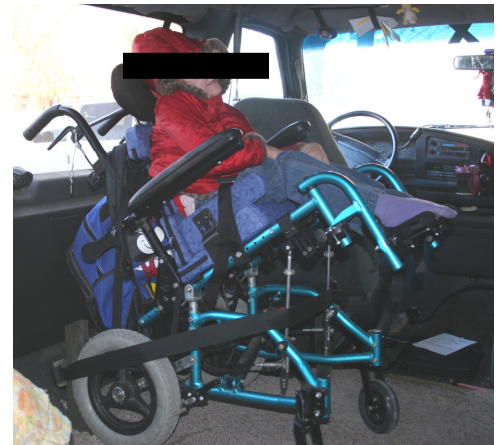
Brenda was being transported in a van side facing in her wheelchair, which does not conform to best practice. Wheelchair securement positions are safer when the wheelchair and the person riding in the wheelchair are facing forward. Sled tests show that side facing wheelchairs are unstable and often collapse in a crash. The van Brenda was being transported in was not equipped with either a four point tie down system or a separate shoulder/lap belt. She only had a lap belt around the front of the frame of the wheelchair.

Wheelchair misuse: Child being transported side facing in a wheelchair, without proper tie downs and a lap/shoulder belt.

Due to the expected lead time in obtaining a special needs car seat through insurance, a car safety seat with a higher weight harness was issued to Brenda to use until her special needs seat arrived. Her father was provided education about installation of the car safety seat and proper securement of a wheelchair in a van.
